Risk-Based Cleanup Plan

**City Pier
Davol Street
Fall River, Massachusetts**

July 15, 2011

Disposal Site: City Pier
Daval Street
Fall River, Massachusetts
RTN Number 4-17012

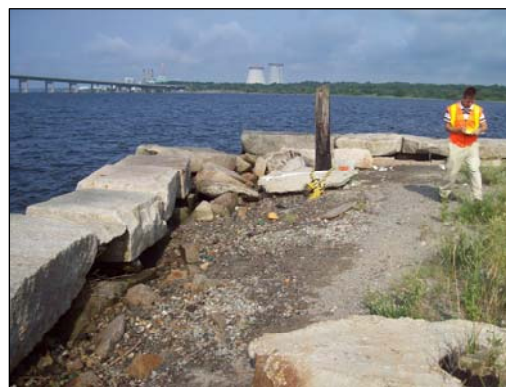
Photograph 1

Seawall No. 1 is 482 feet long and runs east to west. Exposed wall heights vary between 0.0 feet at the east end to 14 feet at the west end. At Station 04+80 the slope of the mudline is approximately 2:1 away from the toe of the seawall. The above-water portion of the stone seawall is in poor condition. Several large voids were generally noted between the stones vertical joints. These voids varied in size but were measured up to 8" wide and extended down to the mud line. Subsequently, approximately 150' of severe embankment erosion can be found on the pier side of the seawall. Random stone blocks were also found to be missing. Erosion of the retained embankment was also present at Station 04+82 where the seawall turns 90° in the north direction (See Photograph 1). Complete deterioration of the seawall at this location, including missing stone blocks, has resulted in a loss of up to two feet of backfill immediately inshore of the wall (see Appendix A Photographs 1 and 2). Specific

underwater anomalies include five large voids in the seawall at Stations 01+60, 01+90, 02+35, 03+20 to 03+32, and 03+50.

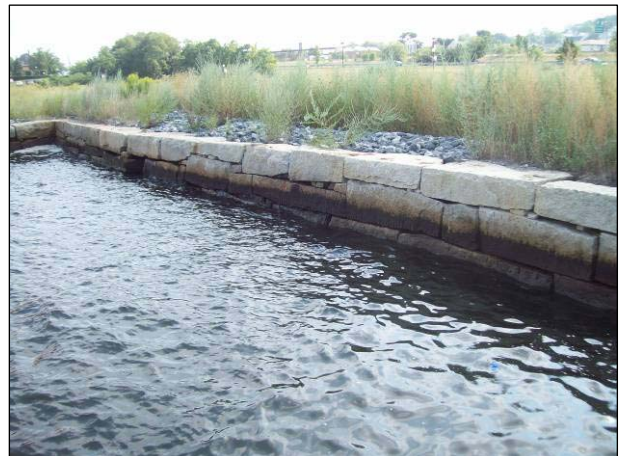
Photograph 2

Seawall No. 4 is 100 feet long and runs south to north. Exposed wall heights vary between 9.5 feet at the south end to 10 feet at the north end. The above-water portion of the stone seawall is in fair condition. Six-inch stone riprap has been placed directly behind the seawall for approximately half its length to help reduce erosion of contaminated soil. One other deficiency noted was the absence of a second course of stone

block. The missing block has created a 5'± square void at the water line (See Photograph 2). Specific underwater anomalies include a large void and displaced stones at Station 07+80, and a large void at the mudline between Station 07+95 and 08+02, with stones observed on the mudline immediately next to the void (see Appendix A Photograph 4).

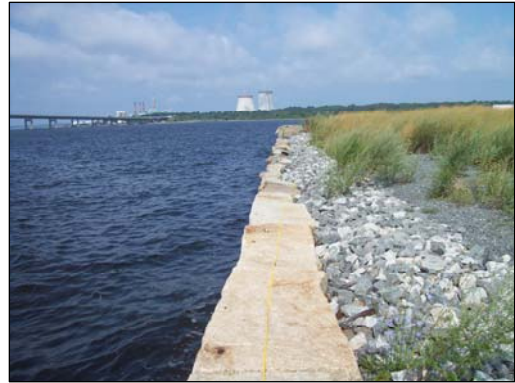
Photograph 3

Seawall No. 5 is 330 feet long and runs east to west. Exposed wall heights vary between 10 feet at the east end to 17.5 feet at the west end. The slope of the mudline is approximately 2:1 away from the toe of the seawall. The above-water portion of the stone seawall is in poor condition. A large percentage of this seawall shows signs of advanced deterioration and/or past repairs. Seawall deficiencies noted include misplaced stone blocks, missing stone blocks, large voids, and localized settlement. Stone riprap has been placed directly behind the entire length of seawall (See Photograph 3). The stone riprap indicates a recent repair measure to help control erosion.

Where the seawall jogs 90° in the north direction, a concrete platform has been poured directly over the top course and extends approximately 20' back over the earth embankment. The platform is in good condition with only hairline cracking present. Specific underwater anomalies include six large voids in the seawall including two at Station 09+10, and one at Stations 09+30, 10+15, 10+85, and 11 +50; evidence of wall rotation between Station 10+30 and 10+95; and wall construction using irregular stones between Station 08+90 and 09+10.

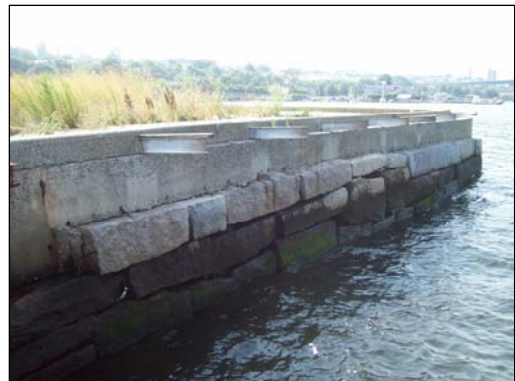
Photograph 4

Seawall No. 6 is 60 feet long and runs south to north. Exposed wall heights vary between 17.5 feet at the south end to 0.0 feet at the north end where the breakwater begins. The above-water portion of the stone seawall is in good condition. A concrete platform has been poured directly over the top course and extends approximately 20' back over the earth embankment. The visibility of the upper stone courses was limited due to the presence of this platform. Visibility of the top surface of the platforms was limited due to debris but did appear to be in good condition with some hairline cracking present. The west face of the platform exhibits moderate scaling of the concrete (See Photograph 4). Steel beams protruding from a concrete cap were also observed along the full length of Seawall No. 6.

The stone block seawall terminates at an earth embankment acting as a quasi breakwater. The breakwater extends into the Taunton River and is protected by large stone riprap. Inspection of the breakwater or slope protection was not performed. Specific underwater anomalies consist of a large void in the seawall at Station 11 +75.

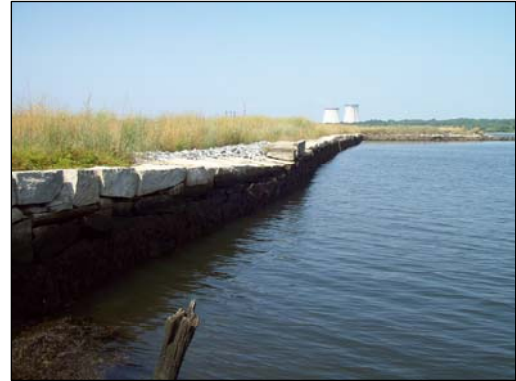
Photograph 5

Seawall No. 7 is 456 feet long and runs west to east. Exposed wall heights vary between 13.5 feet to 0.0 feet at the east end where dumped stone riprap is located. The above-water portion of the stone seawall is in poor condition. Several small areas of embankment repair were found in the form of asphaltic patching and stone riprap. At the embankment repair locations, deteriorated seawall sections were found. Seawall deterioration ranged from missing top course blocks, misplaced blocks, large voids, and attempted repair measures. An 80'± section of seawall was found to be unstable adjacent to one of the embankment repairs. The stone seawall at this location is sloping towards the river and may likely be a result of seawall instability below the water surface (See Photograph 5). Specific underwater anomalies include three large voids in the seawall at Stations 13+85, 14+50, and 15+00.

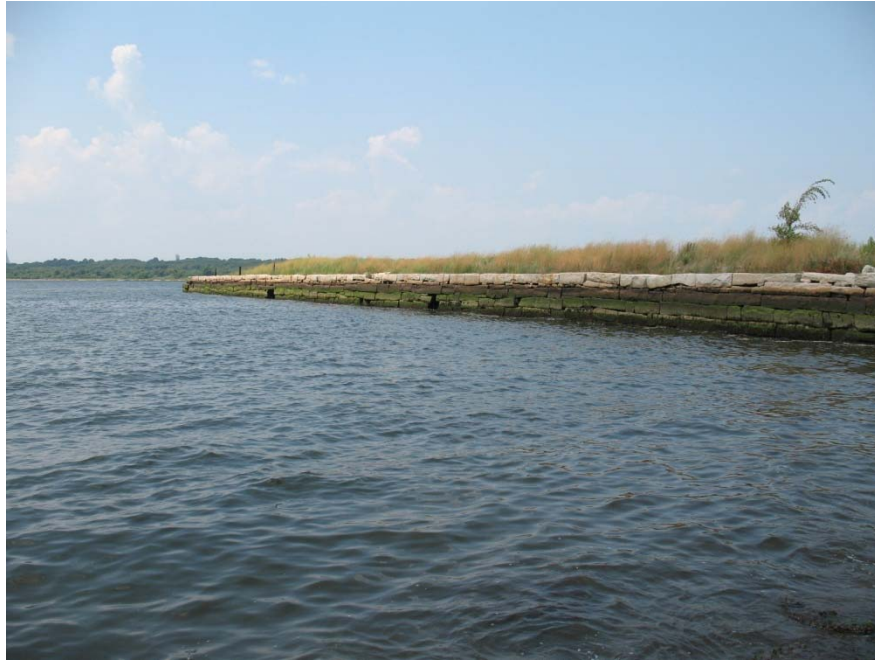
Photo 1: Seawall No.1; individual blocks not square, courses vary in thickness. Note voids in seawall.

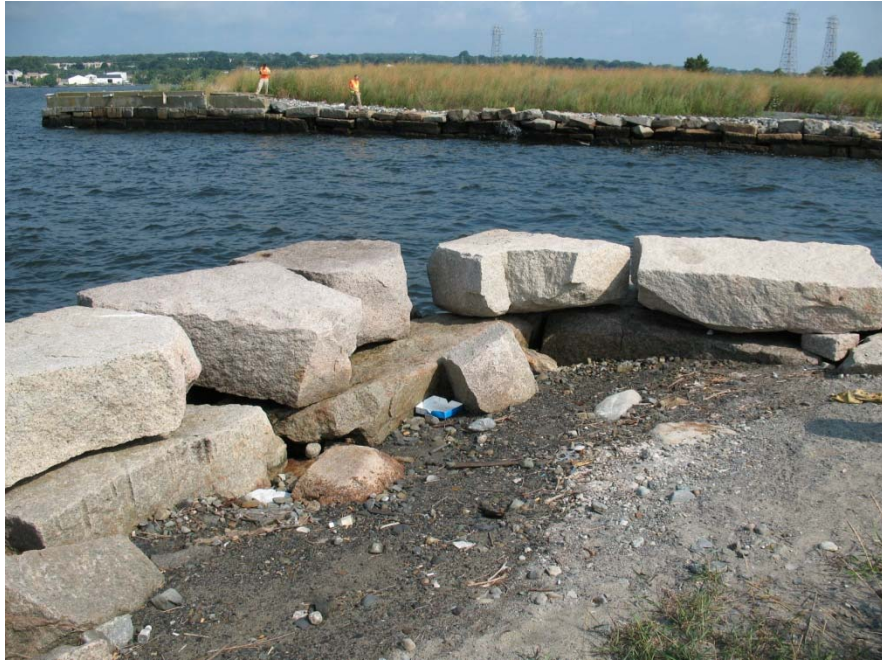
Photo 3: Seawall No.2, STA 5+36; Displaced blocks at corners and loss of up to 2 feet of backfill.

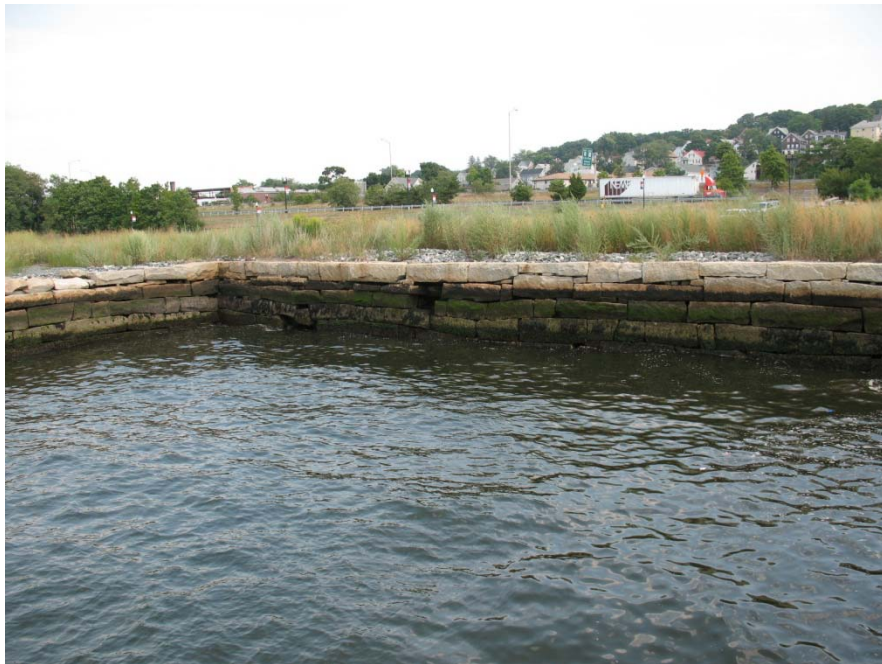
Photo 4: Seawall No.4; Voids in seawall, some blocks observed on mudline.

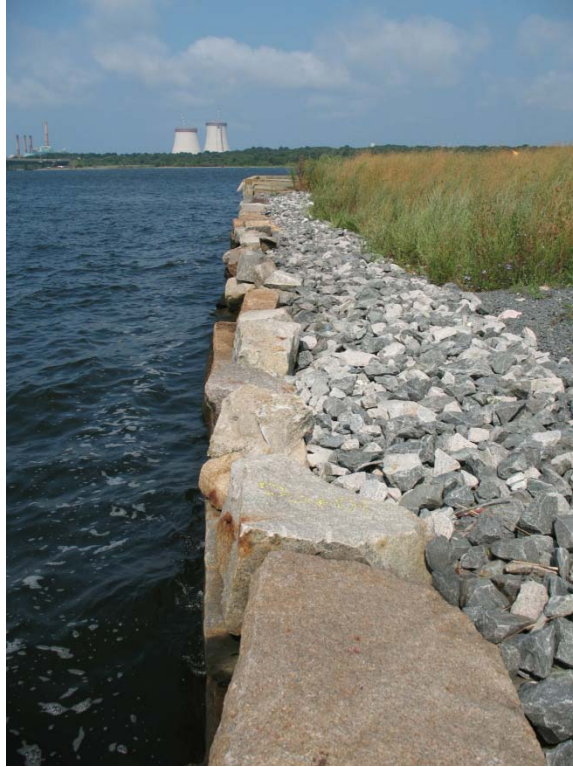
Photo 5: Seawall No.5, STA 10+00; Seawall has been backfilled with 6-inch stone.

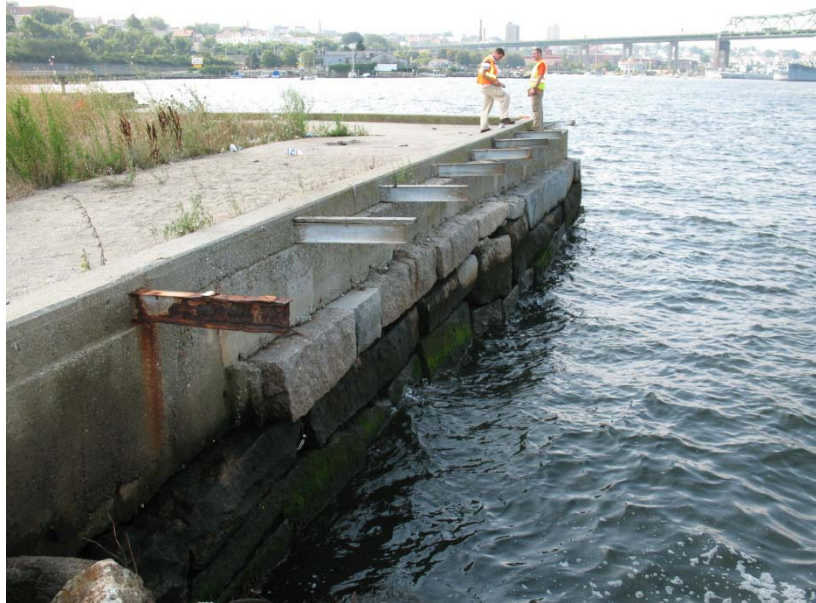
Photo 6: Seawall No.6; Note concrete cap directly on top of seawall with steel beams protruding from the cap.

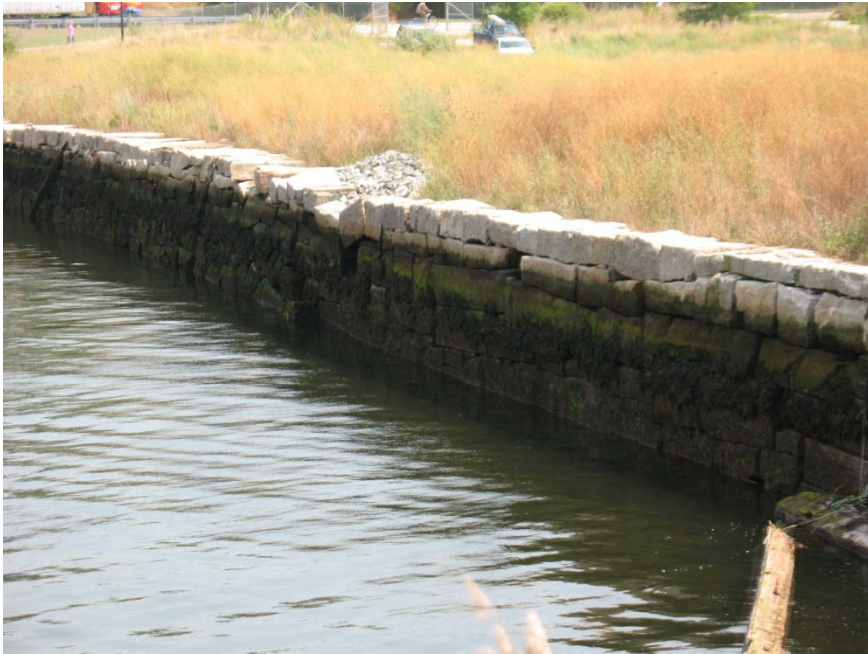
Photo 7: Seawall No.7, STA 13+85; Void in seawall 3' from top. Note block above void that is sliding downward.

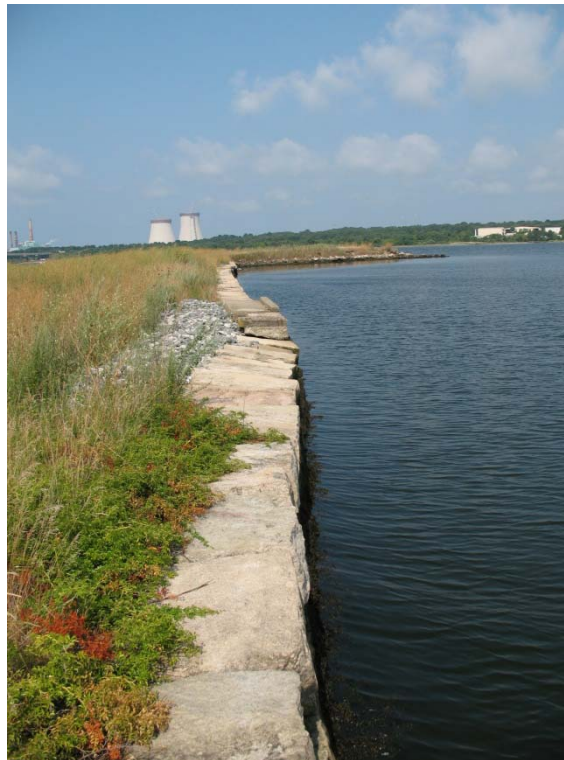
Photo 8: Seawall No.7, STA 18+40 to 18+70; Seawall rotating/bulging outshore.

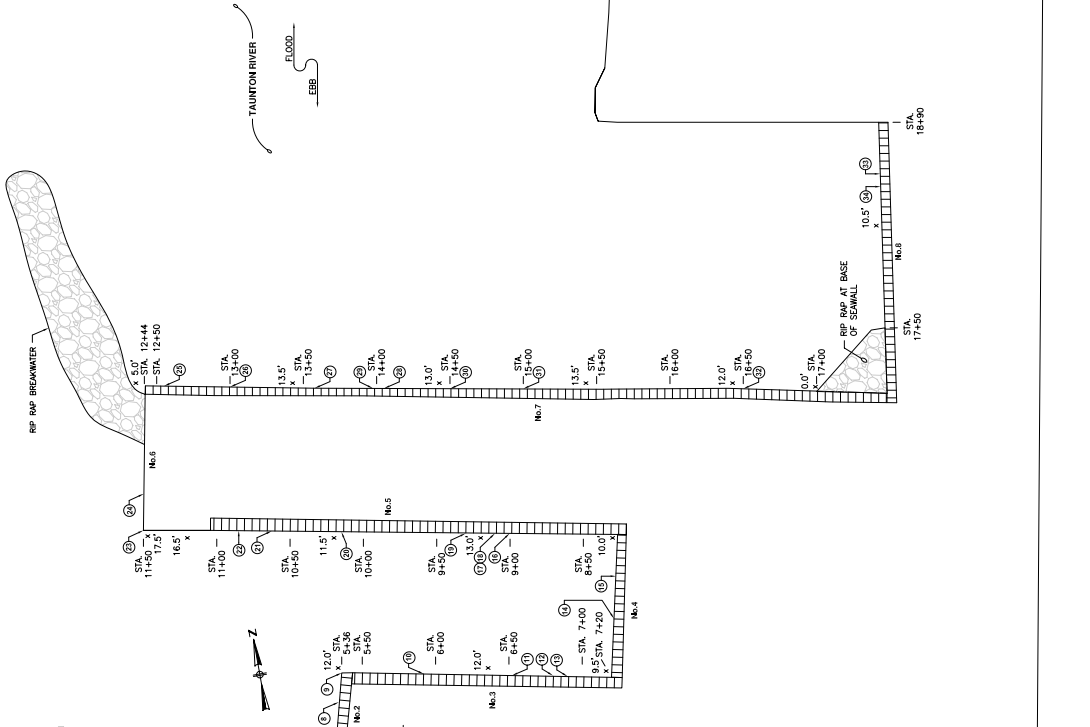
- LIST OF DEFECTS:
- 1 STA 1+400, 24" TALL 24" WIDE x 4' DEEP VOID IN SEAWALL
 - 2 STA 1+400, 6" TALL x 6" WIDE x 4' DEEP VOID IN SEAWALL
 - 3 STA 2+325, 8" TALL x 3" WIDE x 3 TO 5' DEEP VOID IN SEAWALL

- 33 STA 18+440 TO 18+70, SEAWALL BULGING OUTSHORE
 - 34 STA 18+445, 3" TALL x 3" WIDE x 4' DEEP VOID IN SEAWALL
